Fuel Injector Concerns

Correct installation of a diesel fuel injector is critical to proper engine operation. Improper installation can cause serious engine damage and unnecessary warranty claims. It has been determined, based on analysis of injectors returned as warranty defects, that many injector failures are the result of improper installation procedures or defects in the engine's fuel delivery system.

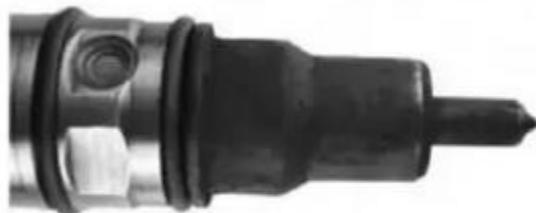
Figure 1: Lack of Copper Washer or Inadequate Torque Injector

Missing Copper Washer or Incorrect Torque

A missing copper washer or poorly torqued injector can allow hot combustion gases into the injector cavity. This will result in the failure of the low fuel o-ring on the injector causing fuel to leak into the combustion chamber when the engine is shut down and hot combustion gases into the fuel system when the engine is running.

Fuel leaks into the combustion chamber can result in hydro-static engine lock up and engine failure. This will occur when the engine is off and the fuel drains past the injectors, tapping into the combustion chamber.

Combustion gases leaked into the fuel system will result in the seizure of the internal components of the fuel injector and failure of manifold injection. Since all injectors share a common fuel rail within the cylinder head a leak in the fuel combustion system will contaminate all injectors.

Black soot on the bottom of the injector is a clear indicator that the injector was improperly torqued or the copper washer was missing.

- Copper washer is present on the injector being replaced
- Copper washer is present on replacement injector
- Ball tubes are free of gouging, nicks, or burrs (6.0L Powerstroke)
- Oil rail ball tubes are aligned correctly
- Injector is correctly torqued – refer to service manual
- Engine oil is clean and at proper level
- Fuel supply is free of water, air, or debris
- Fuel pressure is within specifications
- Injector sleeve is clean & free of damage
- Engine coolant shows no signs of engine oil (sleeve failure)
